R110 - Closet under stairs

Inventory Condition and Assessment Program

Peter Burr House

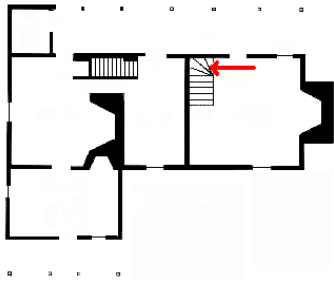
Closet under stairs, R110.

Feature Description	Condition
Flooring	
Northeast white pine tongue and grooved surface nailed flooring, random width was the original flooring of the stair closet.	No flooring except for two broken pieces remains in situ.
Walls	
The east and south walls were the he log and daubed walls of the log crib. Whitewash still heavily coats the walls.	While some daubing is missing, the log walls appear to be in salvageable condition.
The north wall consisted of the whitewashed treads and risers. The west wall was made of vertical boards, tongue, grooved and 1/4" beaded to show into the kitchen. The boards facing the closet were hand-planned and whitewashed.	The risers and treads as well as the w wall appear to be in good condition.
Ceiling	
The ceiling of the stair storage area was the back sides of the risers and the bottoms of the treads. All were originally whitewashed.	
Trim	
There was a plain board narrow trim nailed to the vertical board wall around the door opening to act as a doorstop.	All

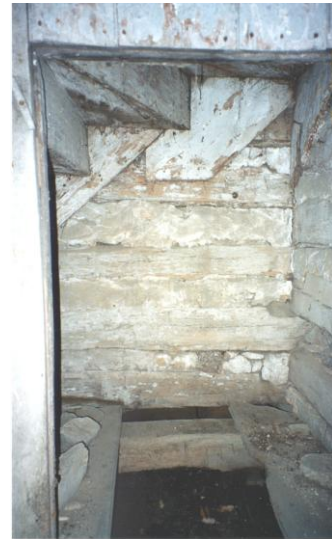
Original Configuration	
The closet retains its original configuration.	.
Alterations	
There were no alterations.
